## **Building Conditions Update**

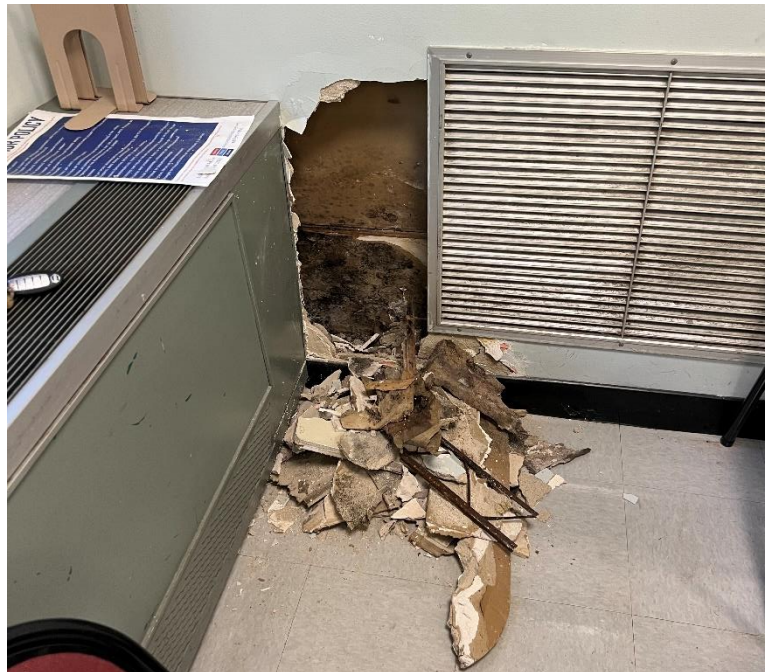
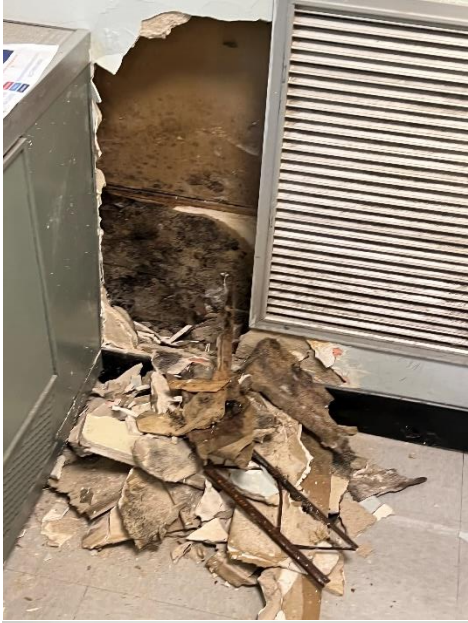
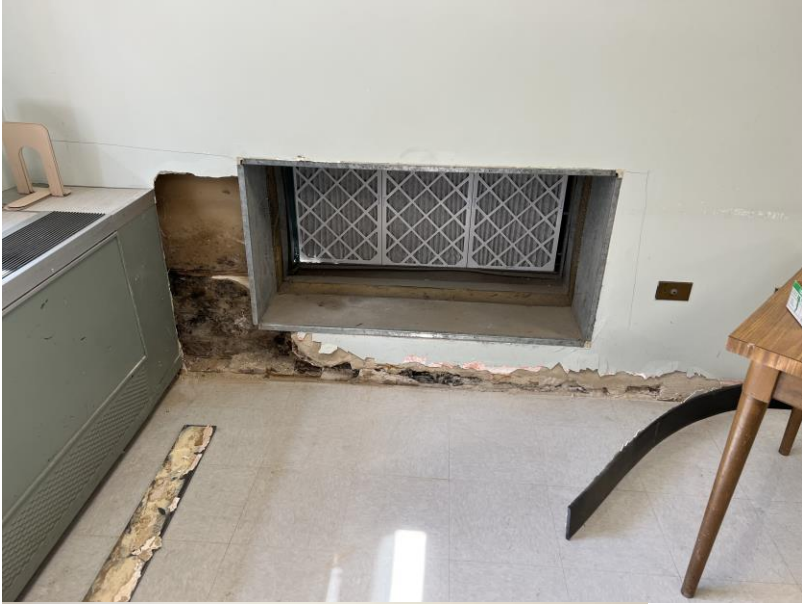
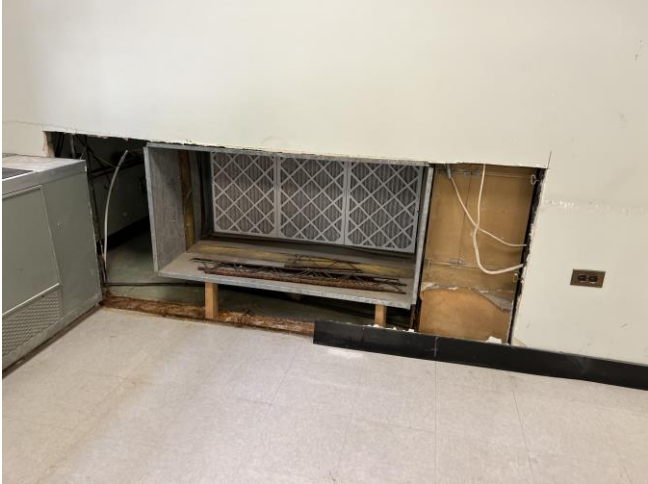
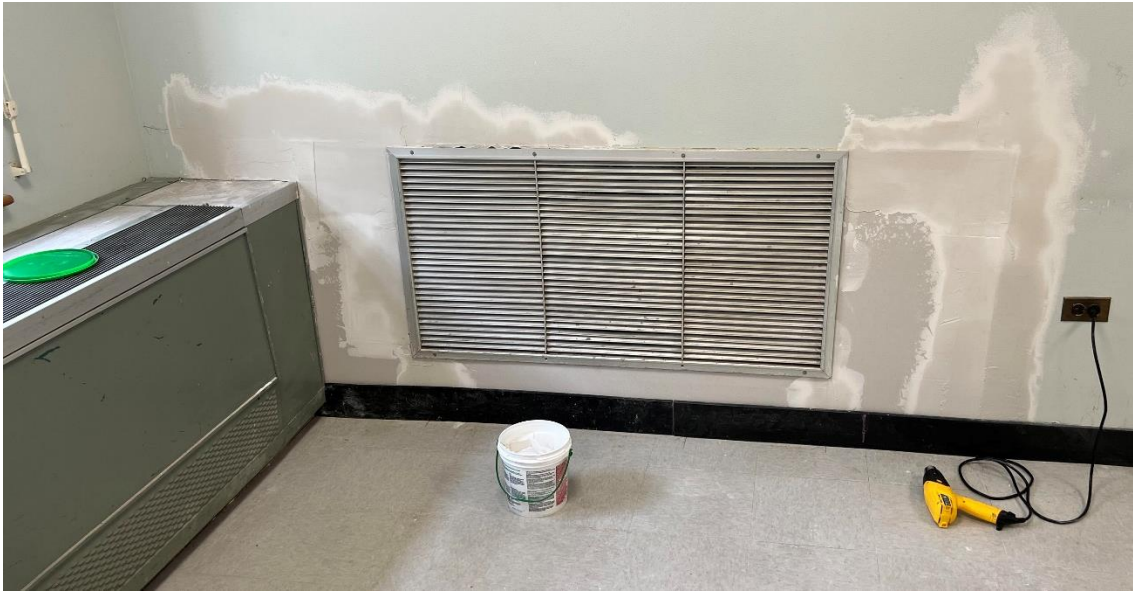
- Recent building issue with a disintegrated wall because of water damage from a leaking pipe. Staff noted a musty moldy smell for some days. After investigation, the wall in the Assembly room was found to be soft and porous (see attached photos of the steps).

- Facilities worked to abate the issue and repair the wall. The Assembly room was out of use for almost a week while repairs were done.
- Note this was the fourth incident of mold concerns in the building over a four-year period. An airborne mold inspection was completed in 2018 and a second one has been requested. Schedule for this is pending.

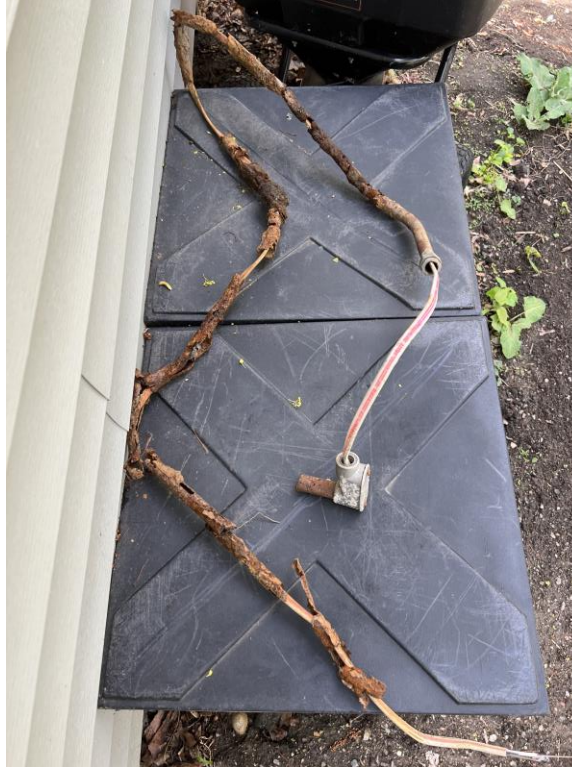
- Outside conduit replace work completed. Excavation of wiring indicates the possibility of a fire. See photo.
