# Belmont Public Library

*Belmont, Massachusetts*

## Historic Objects Conservation Plan

October 2022

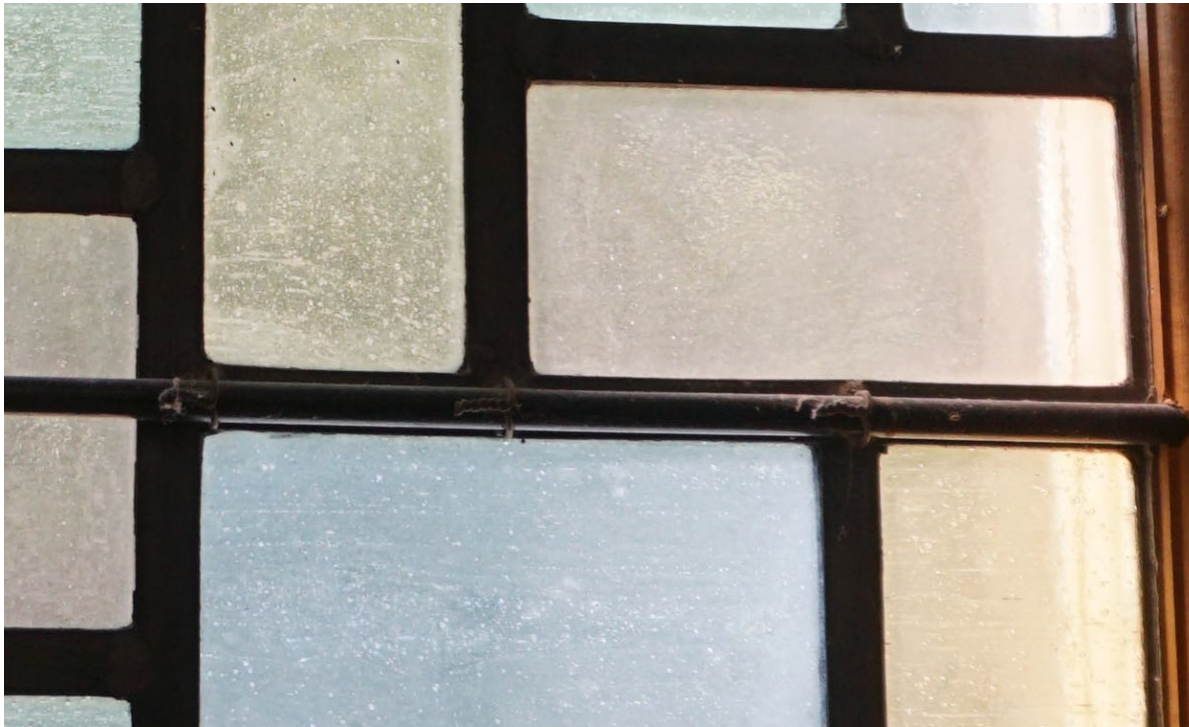
Figure 1. Wire ties connecting stained glass window to saddle bar. This is needed for stabilization, because the lead between each glass pane is very soft.

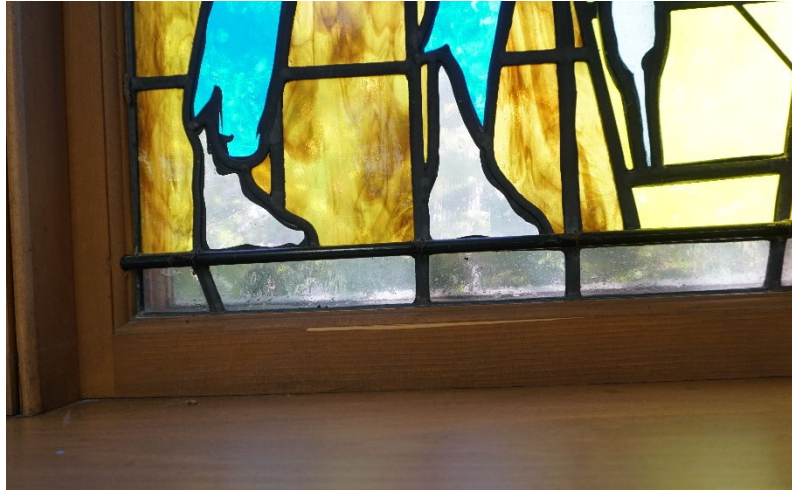
The interior wood sash appear to have been stained, but not finished. They are in good condition, with very occasional scratches. The bottom component of the Tom Sawyer window sash exhibits some minimal signs of moisture damage – raised graining and one crack running along the grain of the wood. The stained glass itself is in excellent condition, as are the lead comes and solder joints. Each window measures 24” wide by 38” high.

Figure 2. Crack in Tom Sawyer window sash.

- Stained glass professional to remove sash to the interior by removing wooden bead holding each sash in its frame and transport to studio to complete work
- General cleaning to carefully remove surface soiling
- Refinish wood sash where finish is worn or missing
- Crate sash in plywood box, install padding between sash to prevent wood to wood contact
- Move crate to climate-controlled storage for duration of construction

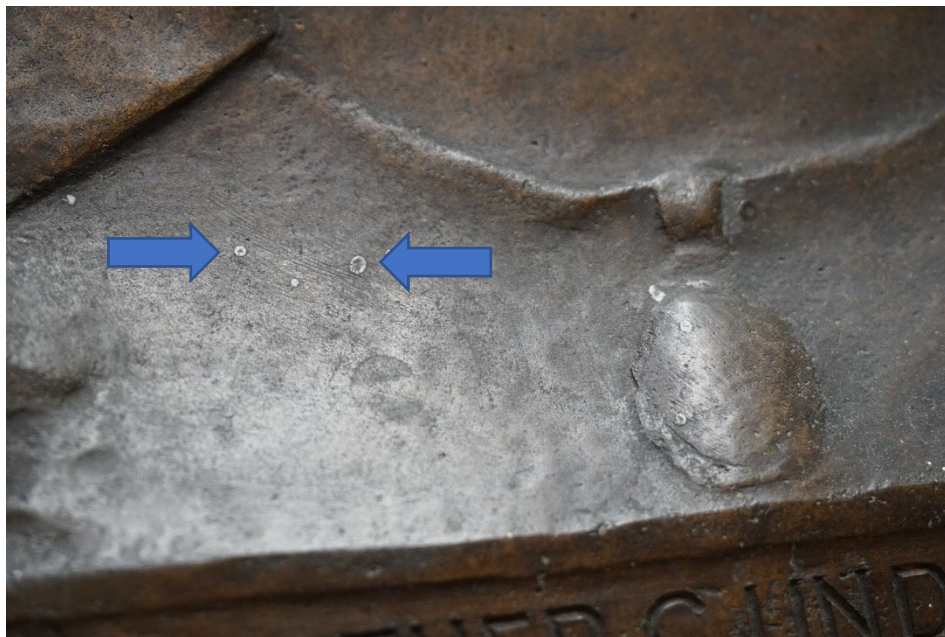
The cast bronze relief plaques of William and Esther Underwood are in good condition, especially considering they are likely 120 years old. There is a stray dab of white paint on the William Underwood bust, and the Esther Underwood bust has some hard, clear spots on the surface that are likely left over from a protective coating. The bust of William Underwood is also covered with slightly darker spots of discoloration. They are firmly affixed to the wall, likely by metal fasteners. Each plaque measures approximately 15” wide, 15” high, and 2” deep.

Figure 3. Hard, clear deposits on the surface of the Esther Underwood plaque.

- Conservator to remove plaque from wall and transport to studio to complete work
- General cleaning to carefully remove surface soiling
- Rework patina to replicate original dark bronze appearance, similar to Esther Underwood plaque
- Apply protective wax coating
- Pack carefully in sturdy box with adequate padding between plaques
- Move plaques to climate-controlled storage for duration of construction

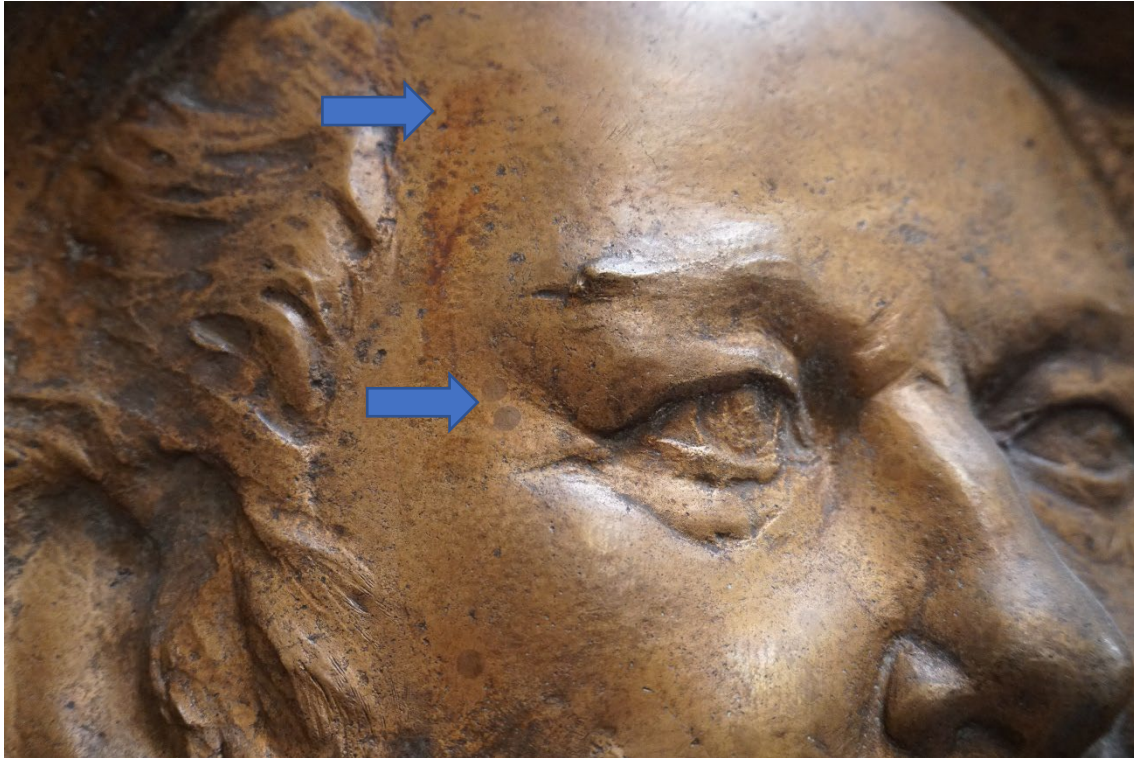
Figure 4. Dark discolored spots on William Underwood plaque.

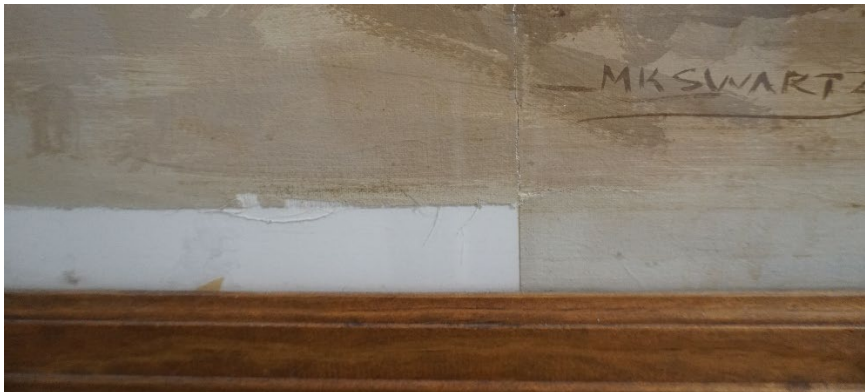
The large mural of Waverly Square c. 1900 was originally painted onto a single square canvas when it was created in 1974, but has since been glued to lightweight foam board and cut into six pieces, likely for ease of transport and framing. The painting is in fair condition. It was clearly exposed for some time before it was framed, because reddish brown stains can be found on the surface. It has torn in a few places along the edges, and some attempts have been made to glue down these torn edges and inpaint over the damage. Where the canvas was cut into six pieces, these edges are bunched and torn where the canvas caught on the blade, and the bottom left corner of the canvas was cut off and is missing.

Figure 5. Missing bottom corner of mural canvas.

- Conservator to remove mural from wall and transport to studio to complete work
- Assess the mural to determine the extent of work required to restore
- Provide estimate to Town prior to starting conservation work
- If the Town approves conservation, work will include general surface cleaning, removal from foam backing, repair of tears, in-painting, cleaning of reddish stains, stabilization and re-mounting on acid-free backing
- Move mural to climate-controlled storage for duration of construction

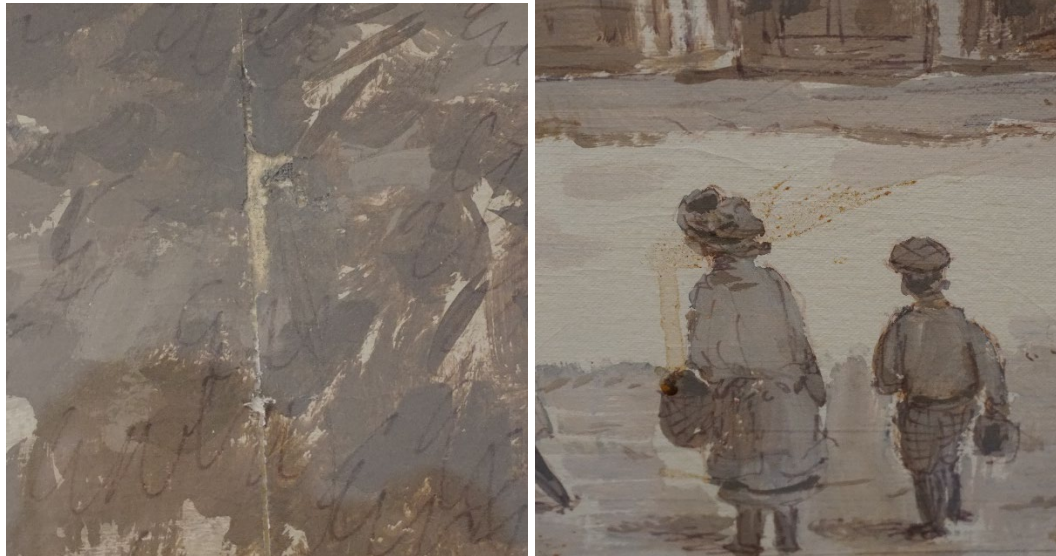
Figure 6. Torn canvas where panel lines were cut (left); Reddish brown soiling (right).

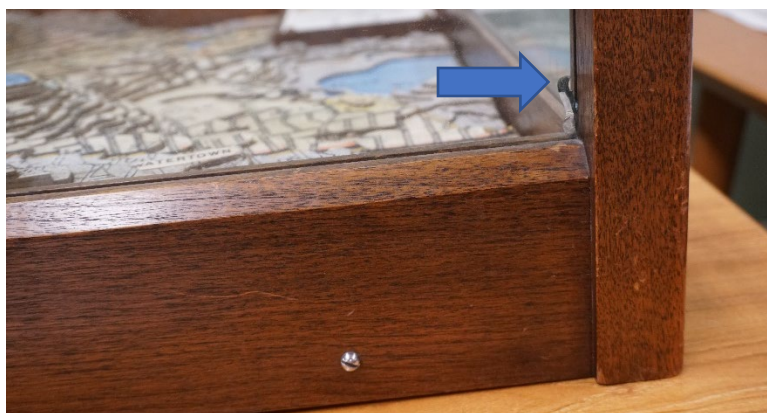
The topographical map has been encased in a freestanding solid oak frame with glass sides and a glass top. The wooden frame is in good condition with some light scratches, and the glass components have cracked in some places. The frame measures 51.5" wide, 34.5" deep, and 7.5" tall.

Figure 7. Break in glass siding and light scratching on oak frame.

- Conservator to remove relief map from wall and transport to studio to complete work
- Lightly sand and refinish oak frame
- Replace cracked glass component
- Clean yellowed glue from elements using appropriate solvents
- Move mural to climate-controlled storage for duration of construction

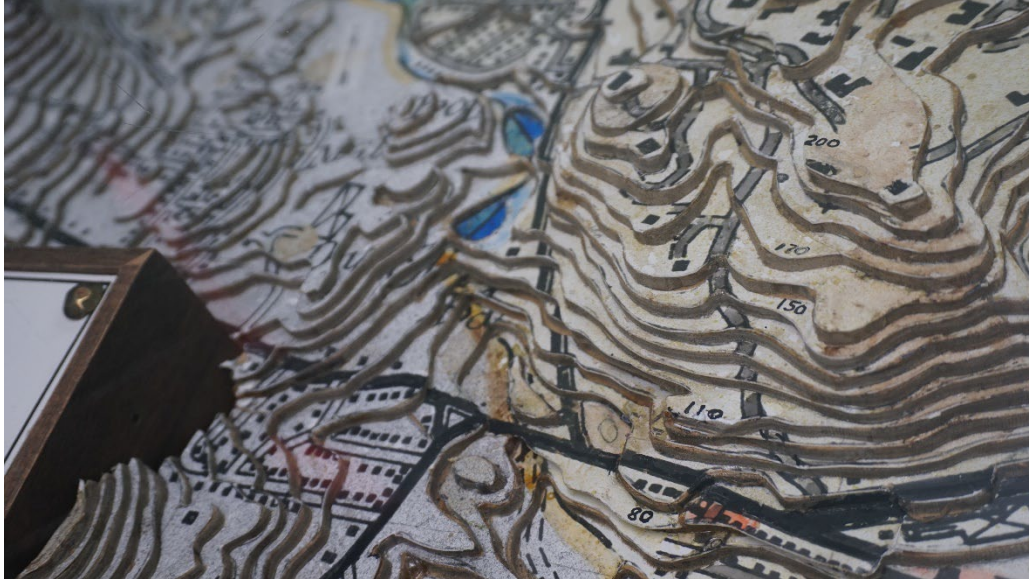
The relief map of Belmont was created by enlarging a U.S. Geological Survey map of Belmont, gluing it to hard cardboard boards, and stacking it to resemble the topography of the land. The topographical map itself is in fair condition. The glue has discolored and is quite yellow where it was applied thickly, and some of the paper has peeled at the edges.

Figure 8. Yellowed, failing adhesive on the relief map.

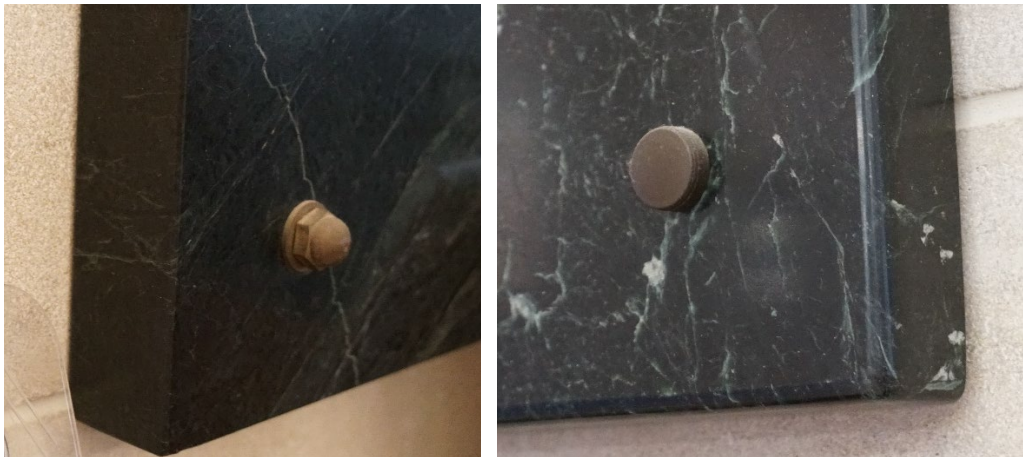
The two small side plaques for the Veterans' Memorial are solid, roughly one-inch-thick pieces of green marble that have been engraved and bolted to the library wall. They are in good condition with no visible scratches or marks. The bolts have been inserted through each plaque via four holes, one at each corner, and are secured to the wall with metal bolts. The left plaque commemorating a soldier from the Global War on Terror measures 31" wide, 21.5" high, and 1" thick. The right plaque commemorating soldiers from the Vietnam Military Action measures 31" wide, 29" high, and 1.5" thick.

Figure 9. Bolts holding plaques to wall.

- Careful removal from the wall by unscrewing bolts
- Pack carefully in sturdy box with adequate padding between plaques
- Move plaques to climate-controlled storage for duration of construction
