# Belmont Public Library

*Belmont, Massachusetts*

## Historic Objects Conservation Plan

October 2022

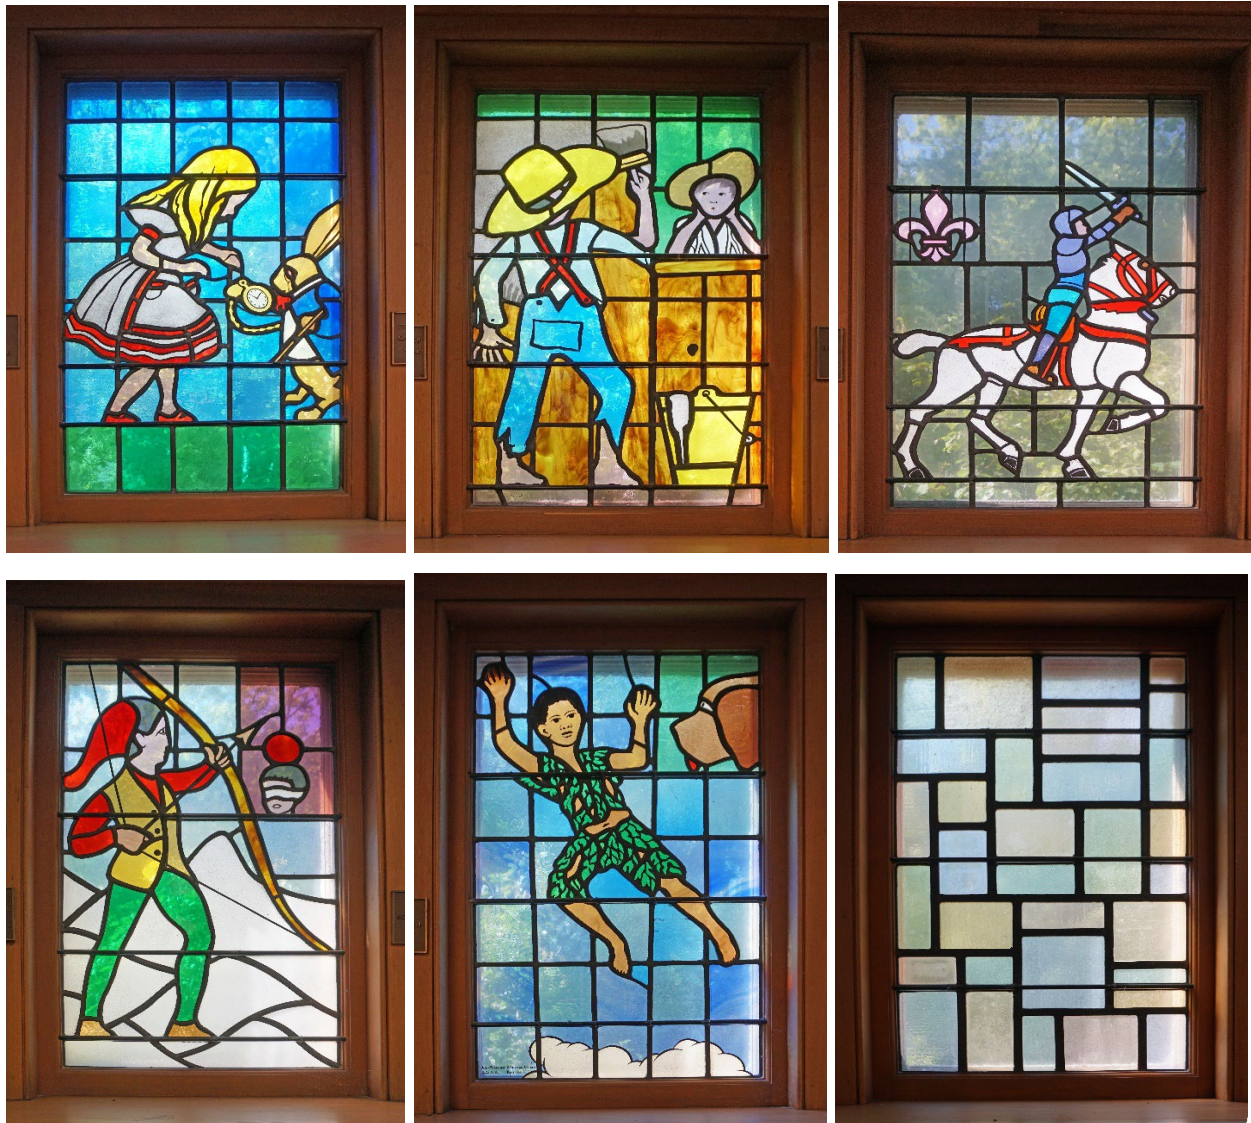
### *Stained Glass Windows*

The nine stained glass windows in the Children's Room of the library were gifted to the library when its current building was constructed in 1965. These windows honor three men who gave their lives in the military, as well as the Belmont High School Class of 1939, and the school children of Belmont who donated generously to the library's cause.<sup>1</sup> The five central stained-glass windows depict scenes from *Alice in Wonderland*, *The Adventures of Tom Sawyer*, *Joan of Arc*, *Robin Hood*, and *Peter Pan*. The four peripheral stained glass windows consist of pastel colored glass in geometric designs.

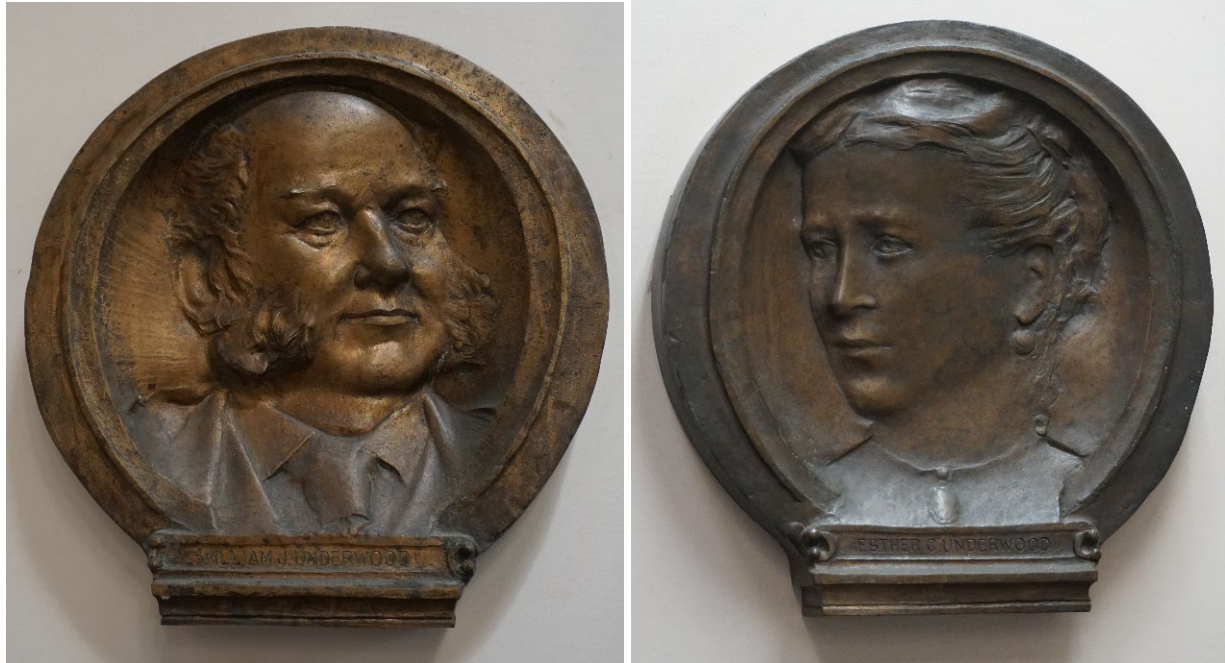
*Bronze Relief Plaques*

Bronze relief plaques of William J. and Esther C. Underwood flank an archway leading into the nonfiction section. Their son, Henry O. Underwood, gifted the previous public library building to the town of Belmont in 1900, in honor of his parents. It is likely that these busts originated in the 1900 library building and were relocated when the library moved to the current building in 1965.

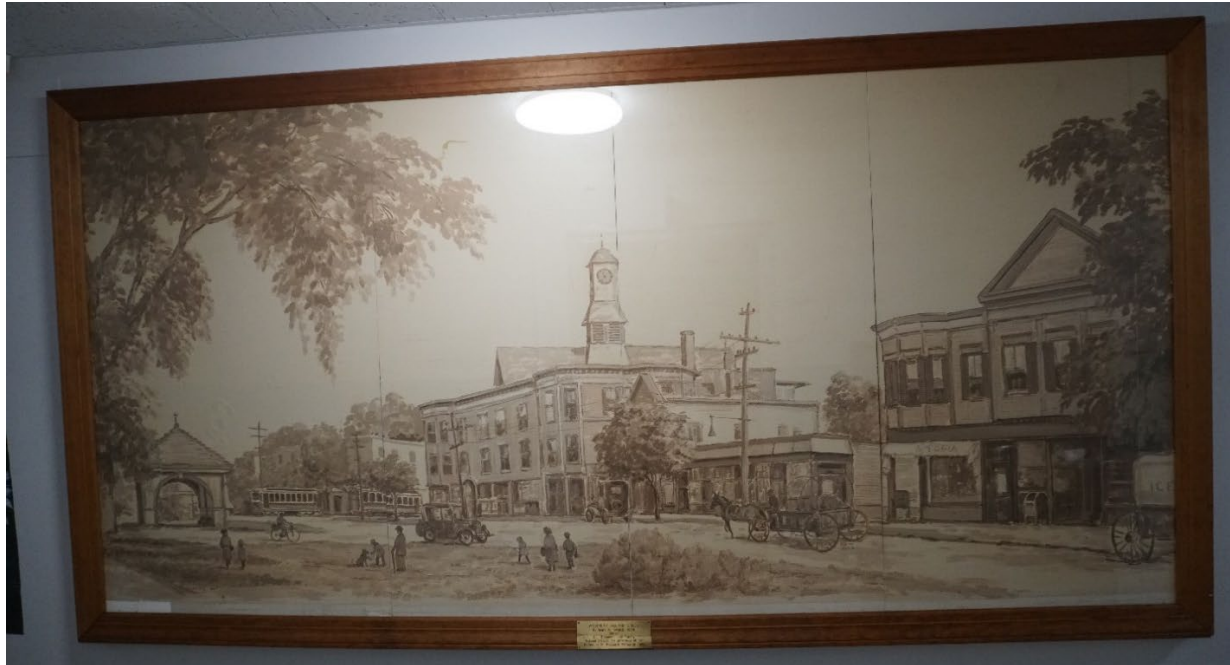
*Framed Mural*

A large mural of Waverly Square in Belmont is currently hanging in a hallway on the ground floor of the library. The mural was painted by Mark K. Swartz in 1974, and depicts the square as it would have looked around the year 1900. Based on its condition, it was exposed to the elements for some time before the Bonnano Family gifted a protective wood and glass frame for it as part of the Katherine M. Packard Memorial Fund.

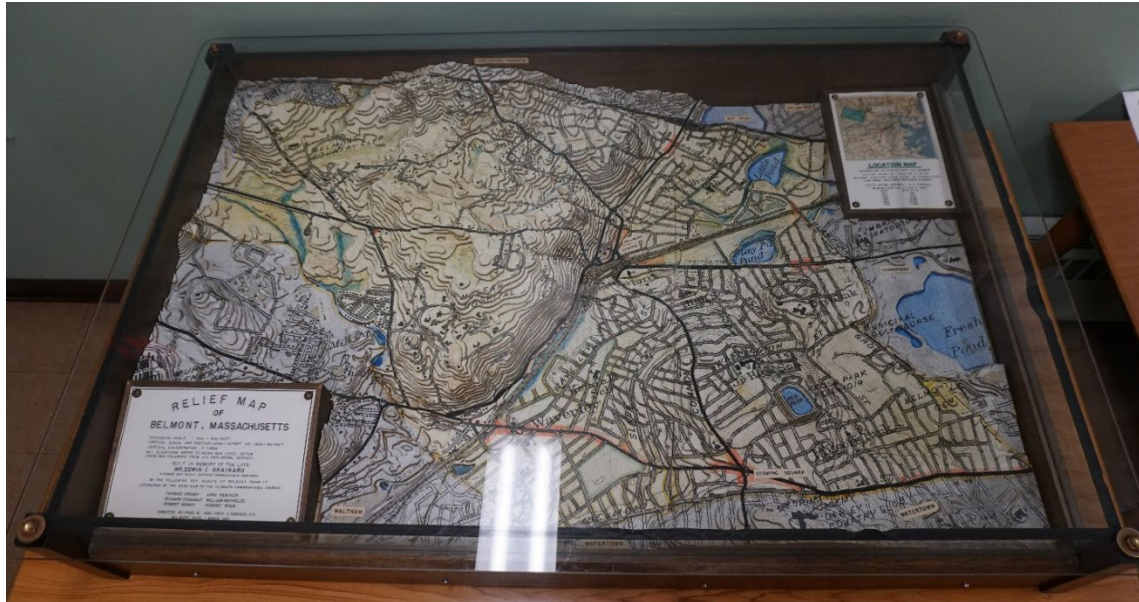
### *Relief Map*

A relief map of Belmont sits on the second floor of the current library. It was assembled by Troop 77 of the Boy Scouts of Belmont in 1951, in honor of their recently deceased district commissioner Edwin Brainard. It was created from a base map of the US Geological Survey, and sponsored by the Men's Club of the Plymouth Congregational Church. The date it was donated to the library is unknown.

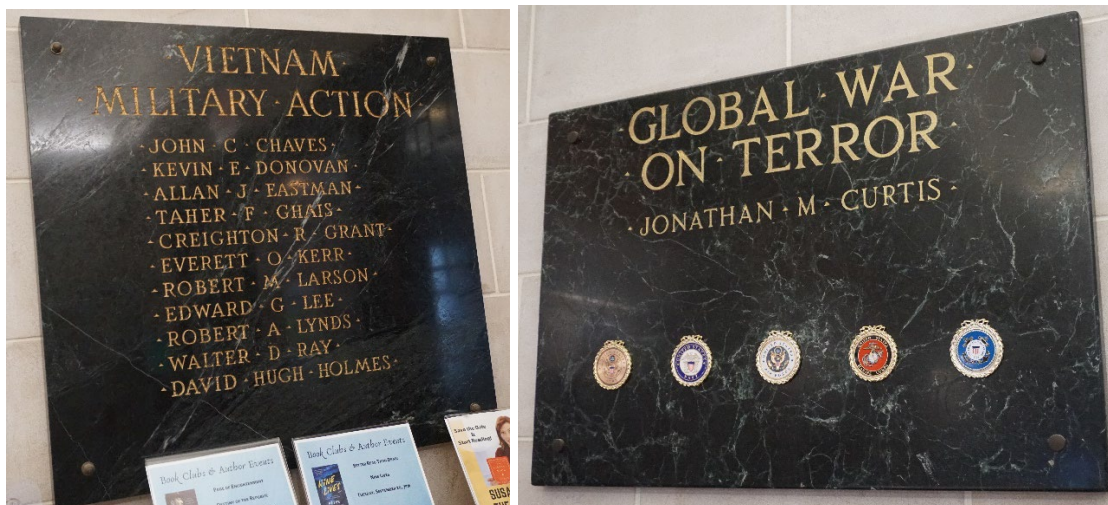
### *Veterans' Memorial Plaques*

Two marbled plaques flank the larger veterans' memorial in the main entrance of the current library building. The larger, central veterans' memorial, which lists soldiers from World War I, World War II, and the Vietnam Military Action, will be remade with a more accurate list of names, as the Belmont Veterans' group has requested. The two marbled plaques on either side of the central memorial, which commemorate soldiers from the Vietnam Military Action and the Global War on Terror, will be preserved and relocated.
