Existing Conditions – Belmont Memorial Library Site Building Renovation & Addition Issues

Preferred Option

Schematic Design

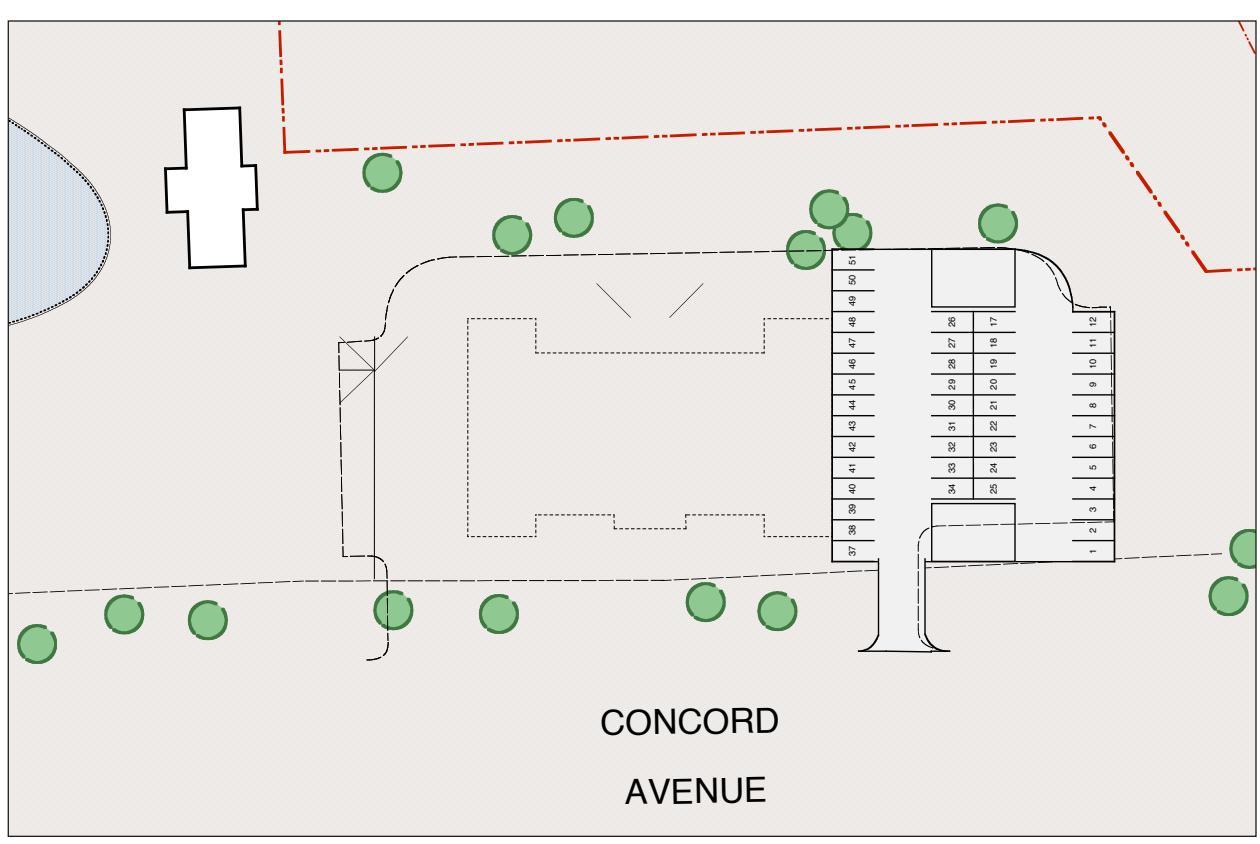
Option 1B Site Plan

Option 1B wraps the existing library building with additions on three sides. Because of the configuration of spaces within the existing structure and the constraints on areas for expansion, accommodating the building program requires more square footage than the building program calls for due to the inefficiency created by those constraints. For instance, areas within the existing structure are divided by bearing walls that cannot be modified creating some rooms that are larger than program requirements. The narrow additions dictated by the site constraints result in rooms that are difficult to efficiently utilize.

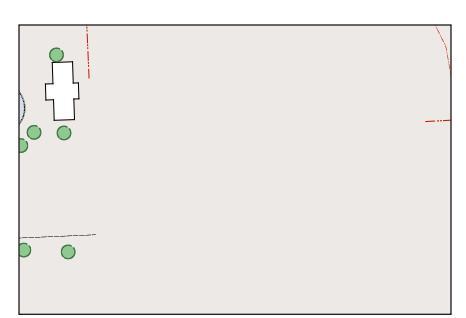
Option 2B Site Plan

The main level of the library contains library administration and workspaces, the circulation desk, children's services, meeting room, and book sale room.

The upper level contains the adult reading areas, book stacks, popular materials and historical collections.

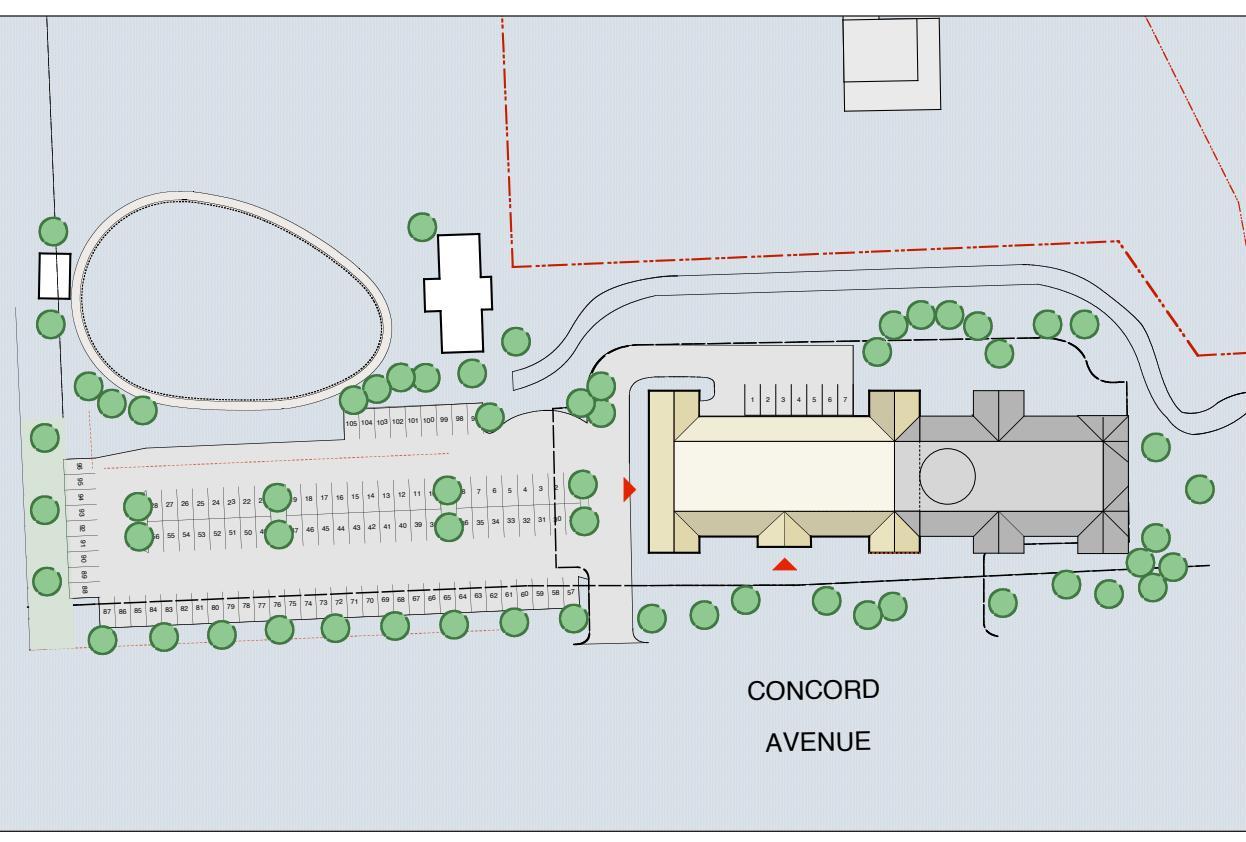
Option 3 Site Plan

The most significant drawback to Option 3 expressed by the building committee was the appearance of parking in either a garage or a surface lot and it's visual impact from Concord Avenue and the park.

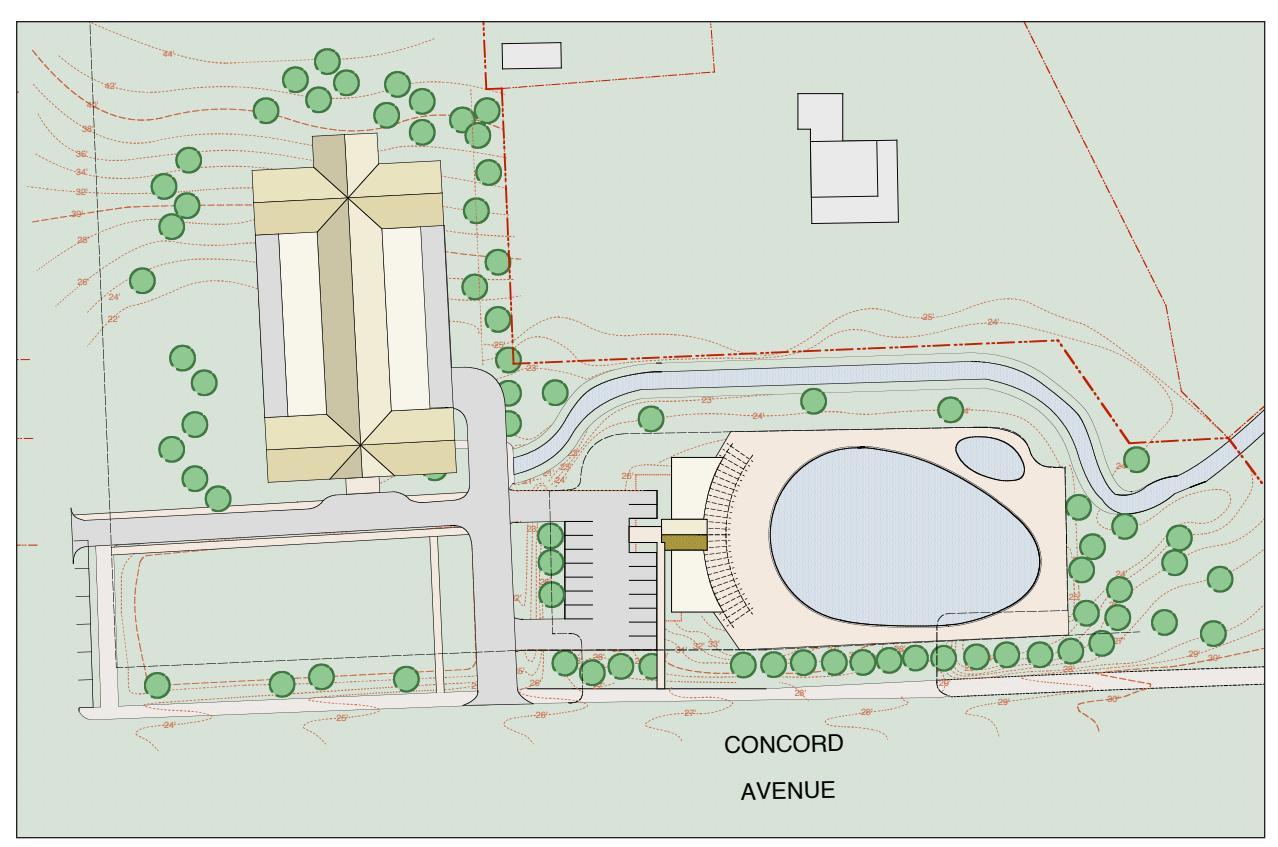
Option 5B Site Plan

Of the options considered 5B was selected as the preferred option. This option creates a new three-story structure built into the hillside with one level of parking at grade at the lowest level. The lowest level also contains an entrance lobby loading facilities and mechanical spaces with the balance of library functions on the upper two floors.

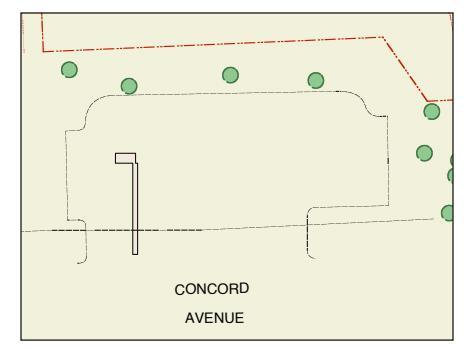
Option 5B Site Plan - Pool

Option 5B calls for a new pool of the same size and shape as the current pool with an additional wading pool. The pool house provides a controlled entrance point into the pool area.

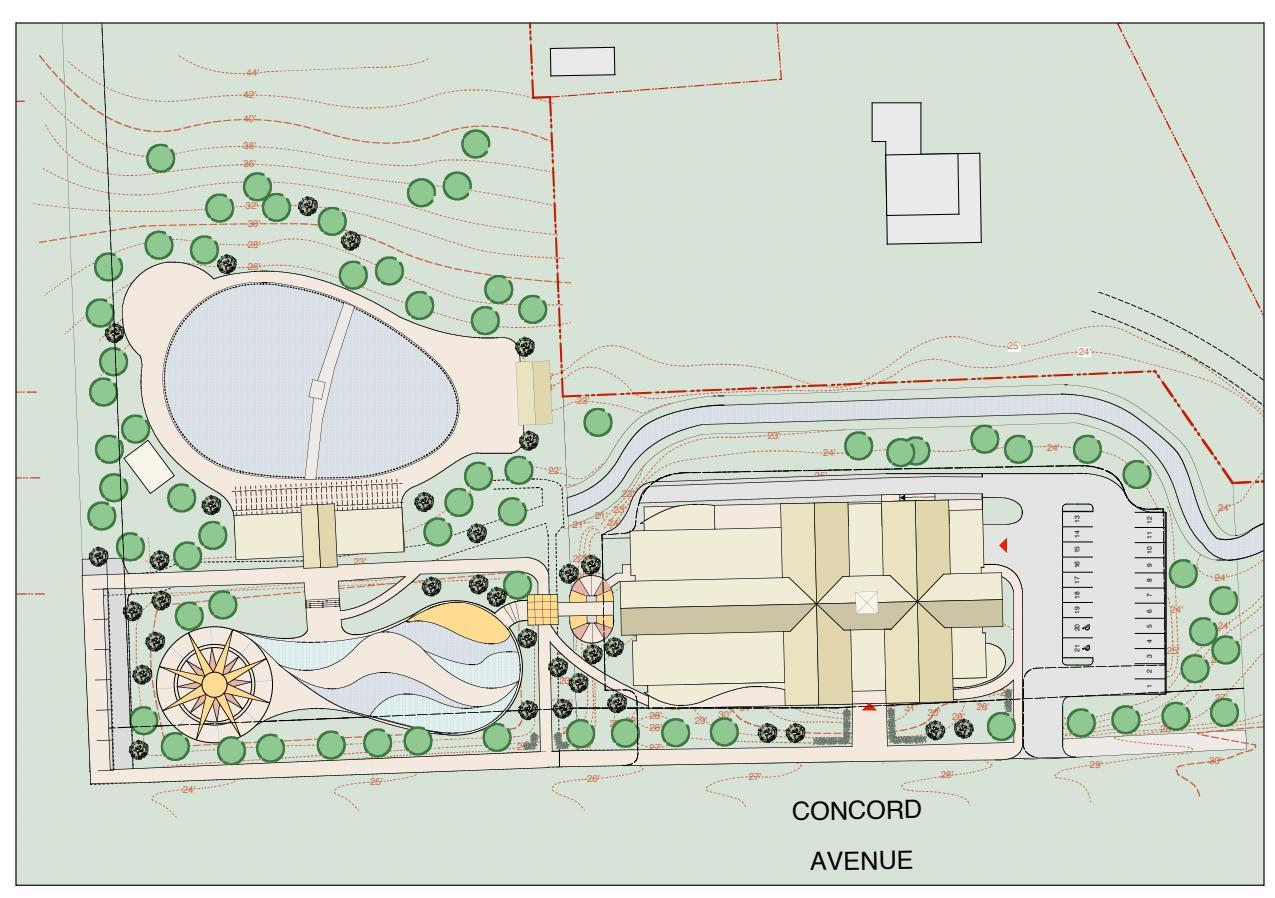
Option 6 Site Plan

Option 6 proposed to develop the bowl area to create an addition amenity for the town. The bowl area is to be developed into an area which functions a spray park in the summer and an ice rink in the winter. The pool house is located between the bowl area and the pool to serve both areas.

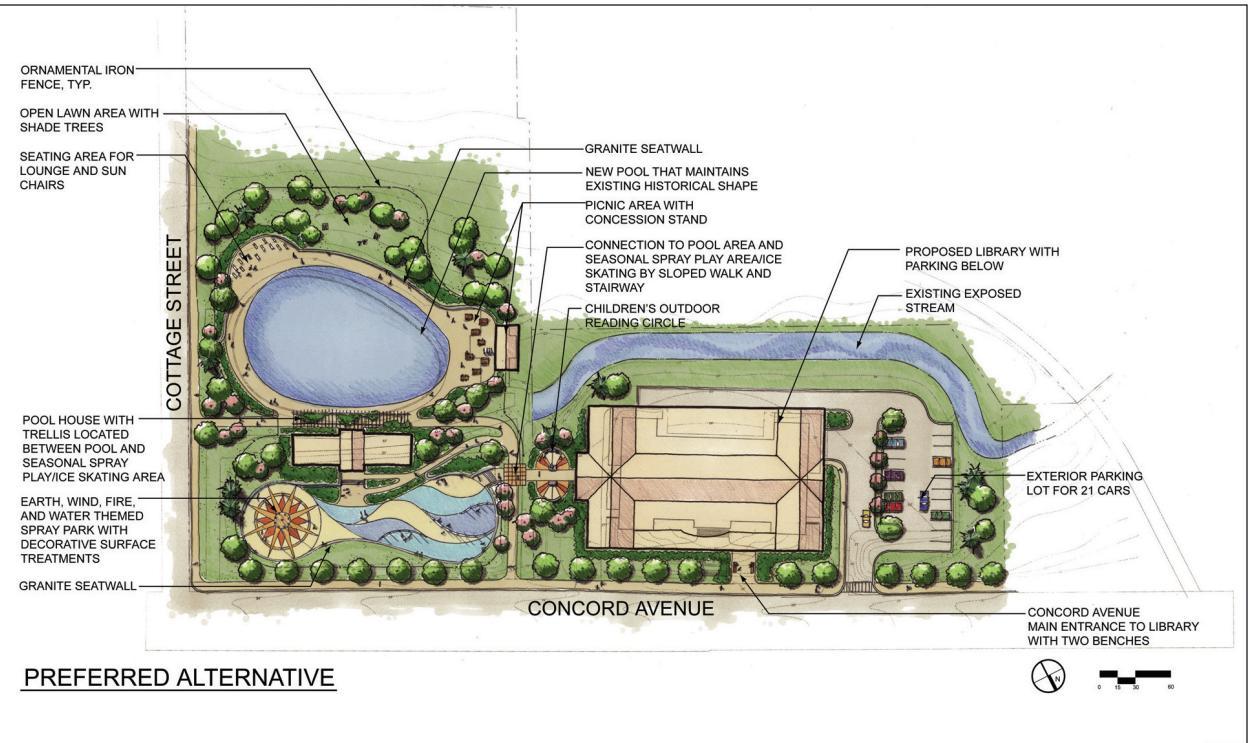
Option 6 Landscape Plan

Carol Johnson Associates prepared a landscape plan for Option 6.

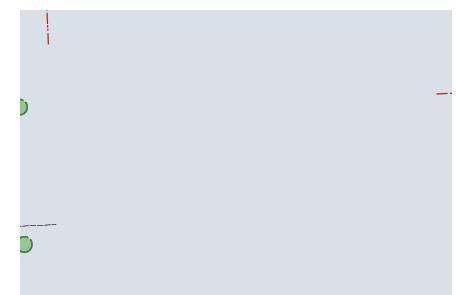
Schematic Design Site Plan

The grade drops approximately three feet from the street to the back of the building. A ramp is located at the side of the building to provide access to the parking level.

An outdoor story garden is planned at the east end of the library building adjacent to the pool site. Located just outside of the children's department, this area will provide an outdoor place for children's programs in nice weather.
